Cross section PR122A was established in 1979 across a new cutoff channel that had formed during the 1978 flood across the neck of a meander bend in Powder River at the mouth of Flood Creek. As the 1978 flood flowed across the neck of the bend, several gullies formed on the downstream bank of the meander neck (see 1979 profile in the PR122AComposite data file), and began cutting their way headward across the neck. One of these eventually succeeded in breaching the neck and diverting the main flow of the flood waters (Gay *et al.*, 1998, *their* Figure 8; Meade and Moody, 2013, *their* Figures 11 & 12). Because the cutoff was completed late in the flood, the width of the new channel remained fairly narrow--45-m on the line of section. Along the right side of the new channel, extending from the thalweg at station 38 to the right bank at station 75 (destined to become a point bar), the initial bed sediment was primarily gravel, plus some sand. The channel was bedrock-controlled, and had a downstream slope of 0.0043 (several times steeper than the average slope of about 0.001 for Powder River).

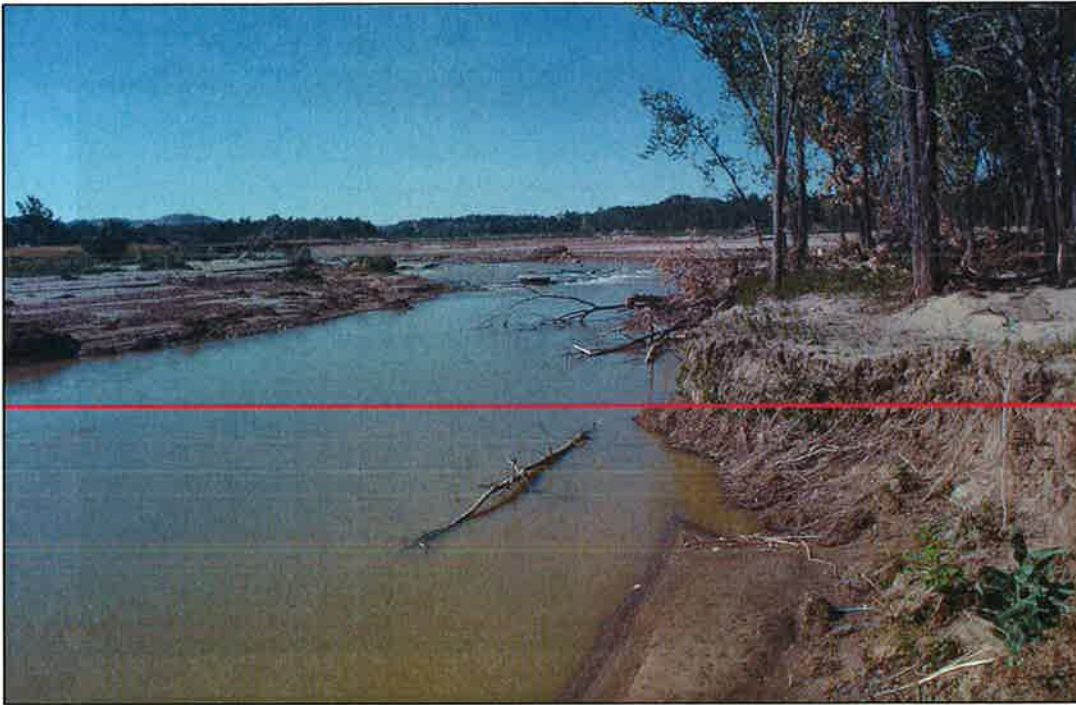
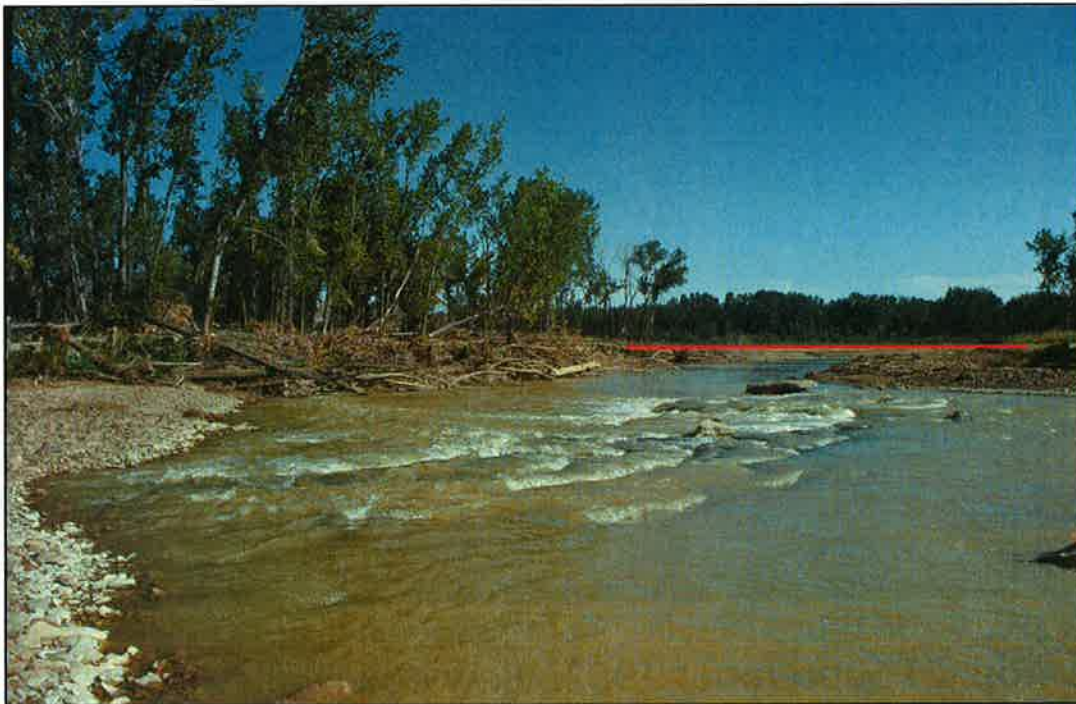
PR122A. **Top.** 4 September 1978. View upriver through the cutoff showing the bedrock rapids through the new channel formed during the 1978 flood. **Bottom.** 4 September 1978. View downriver of bedrock (coal) rapids. Red line shows approximate location of section PR122A.

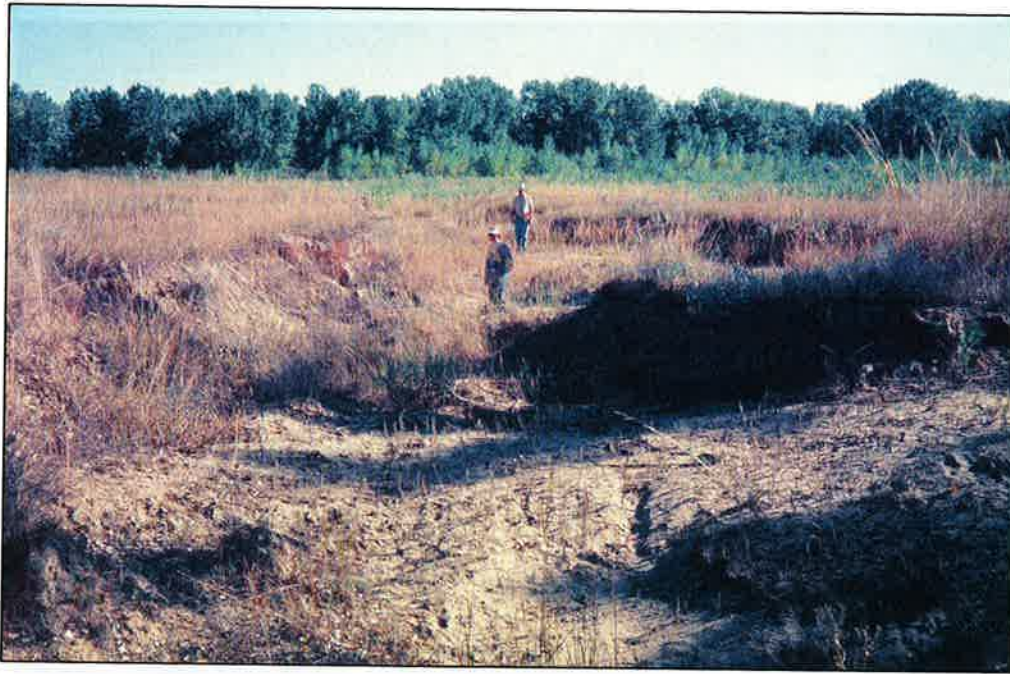
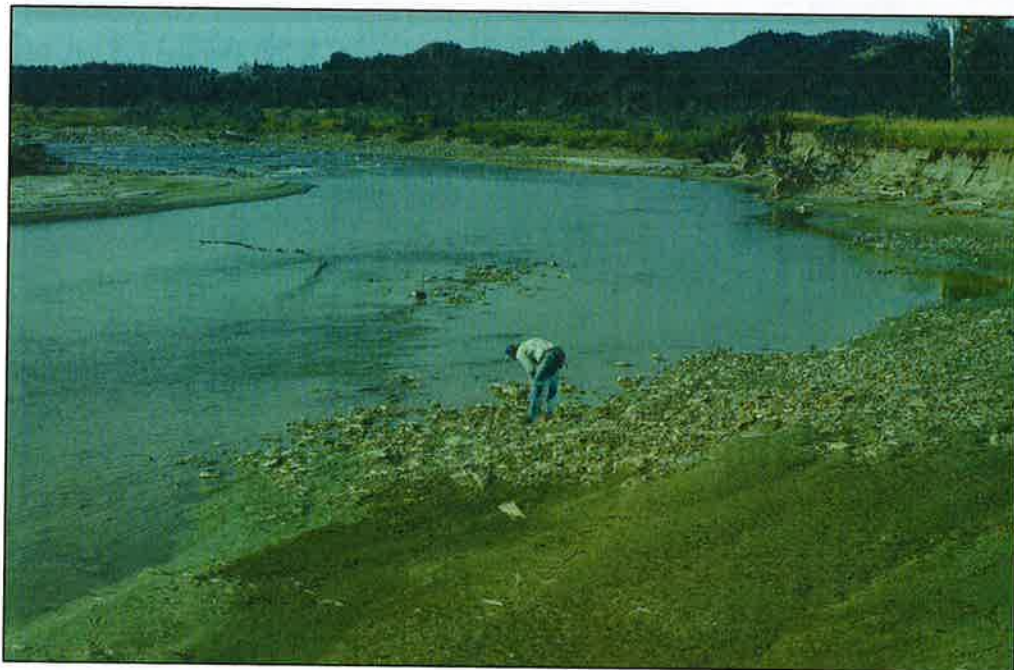
PR122A. **Top.** 21 September 1982. View downvalley through a headcut that crosses section PR122A near station -40 (see profile in data files). S. Stewart (~1.5 m tall), in the foreground, is standing on the section and M. Karlinger is standing downriver of section PR122A. **Bottom.** 5 September 1984. View is upriver, J. Moody is standing on the line of section, and the bedrock rapids can be seen at the top of the photograph.

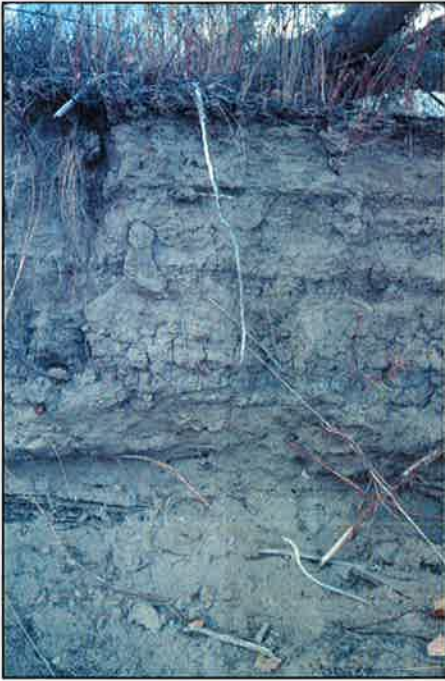
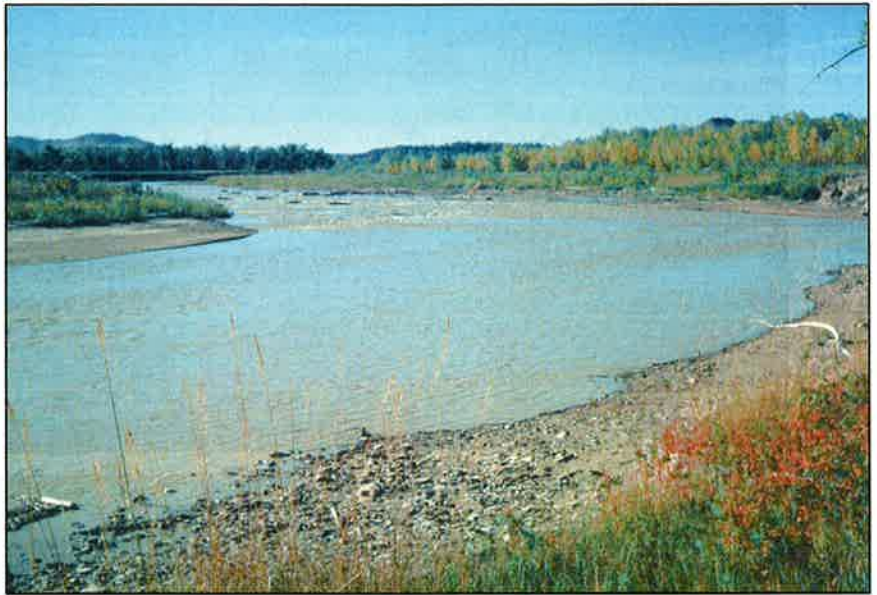
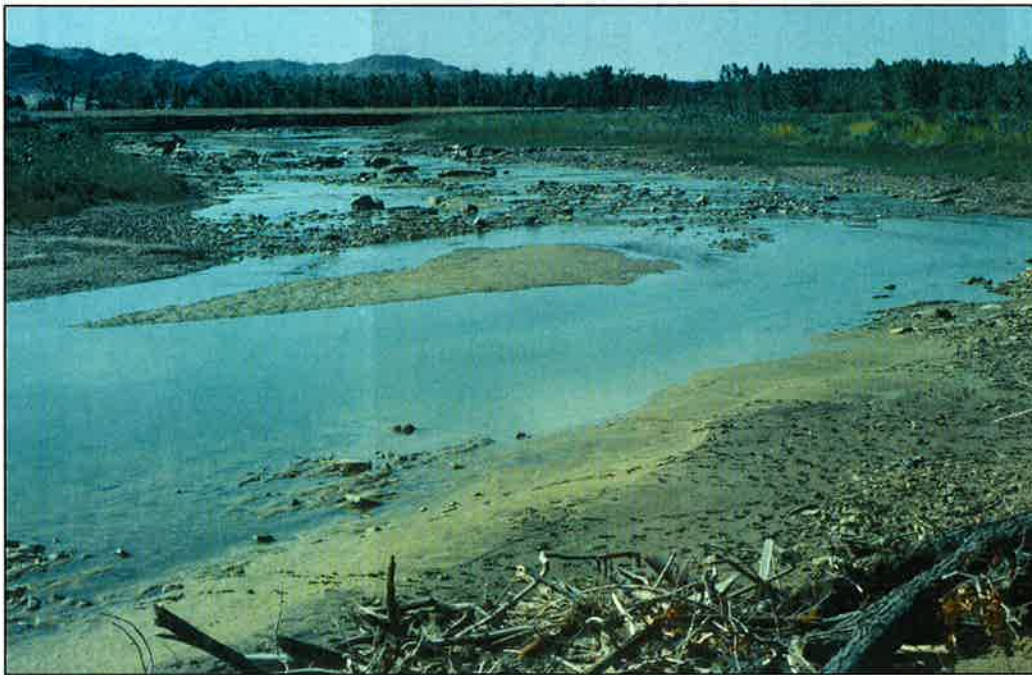
PR122A. **Top.** 4 October 1985. Three overbank deposits on left bank 36 m upriver from section PR122A (top layer is 25 cm thick. **Middle.** 22 September 1987. View is upriver from ~ 20 m below PR122A **Bottom.** 29 August 1991. View is upriver showing the bedrock.

Between 1979 and 1985 the bank-to-bank width of cross section PR122A increased from 45 to 62 m without much consistent deposition of sediment. In 1985 and again in 1987, layers of sand (0.1-0.6 m thick) were deposited between stations 43 and 76; and then in 1989 an ice flood deposited additional sand and gravel between stations 50 and 75 and this became the foundation of the point bar (Moody and Meade, 2014). More sediment was added to the point bar in 1990, 1993, and 1995, while the channel continued to widen to 90 m (double its initial post-flood width) by 1999. The width has remained stable from 1999 to 2013 with only about 2 m of widening in 2011, while substantial amounts of sediment were added to the point bar in 2002, between 2003 and 2006, in 2008 (0.2-0.5 m thick), and by another ice flood deposit in 2012 creating an irregular topography. The 2013 survey indicated that this ice-related, irregular topography on the point bar had begun to smooth out.

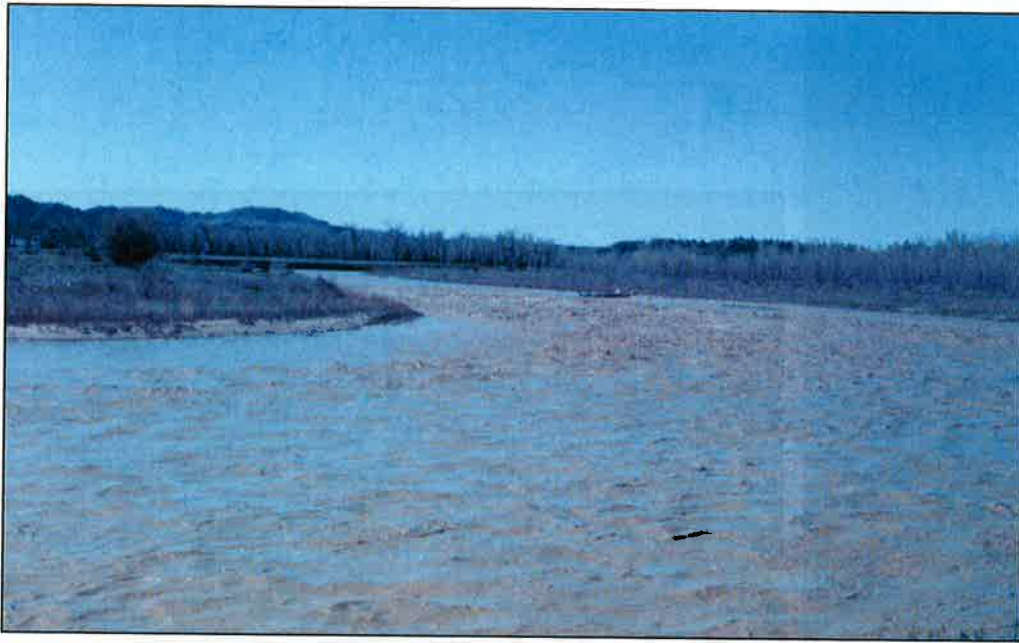
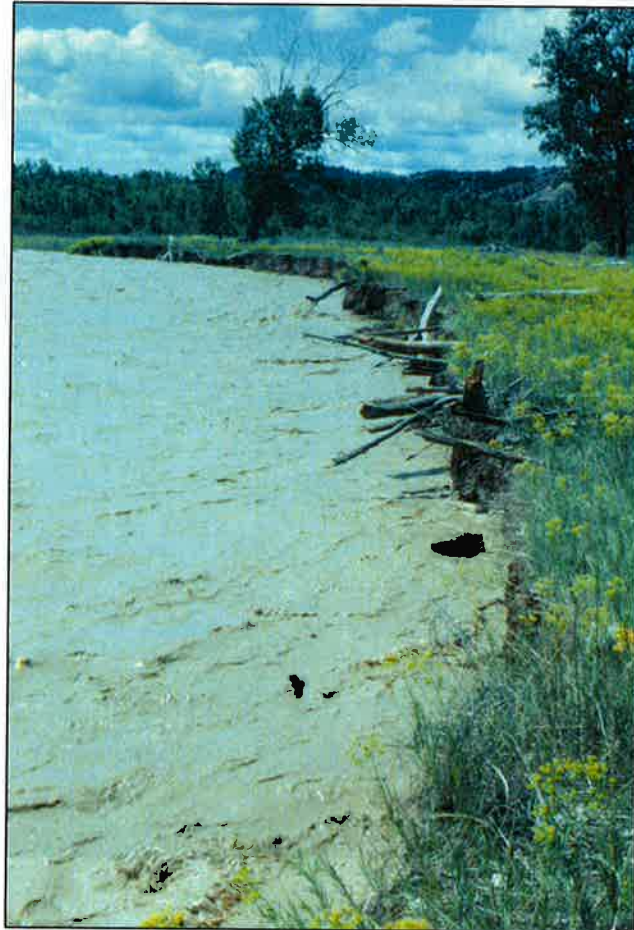
PR122A. **Top.** 10 May 1993. View is upriver from PR122A showing the bedrock rapids at higher flows than previous photos. **Bottom.** 9 June 1993. View is upriver, tripod is on section, and water level is 1008.9 m

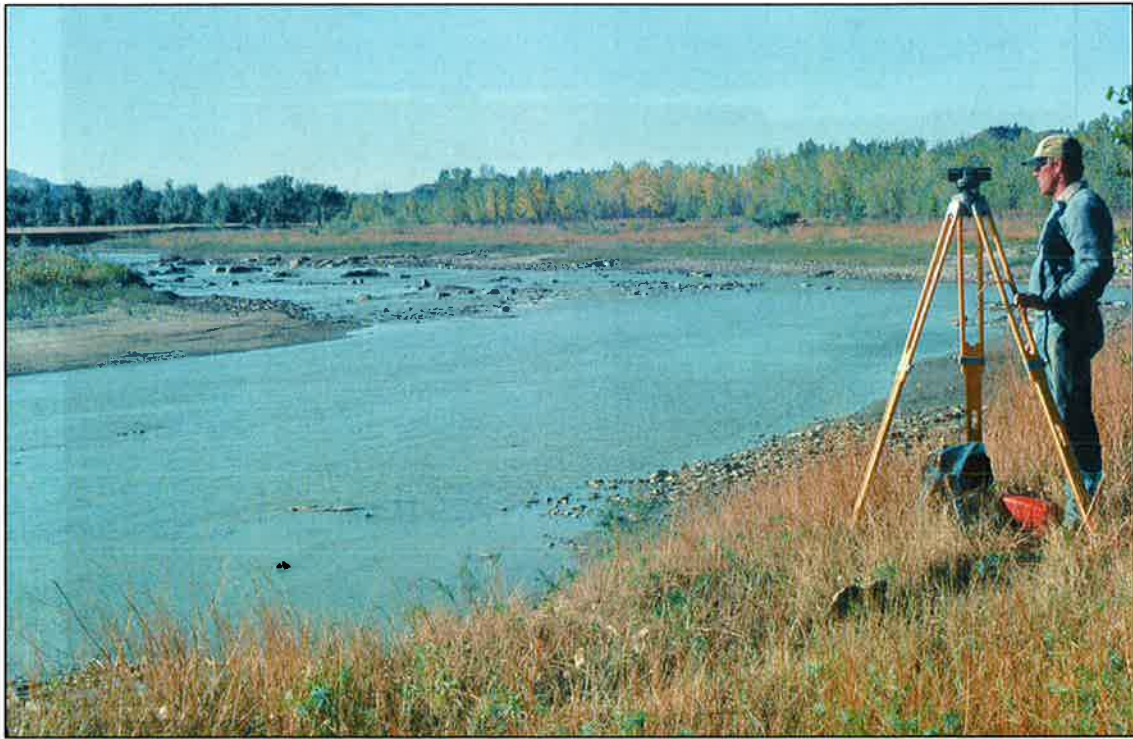
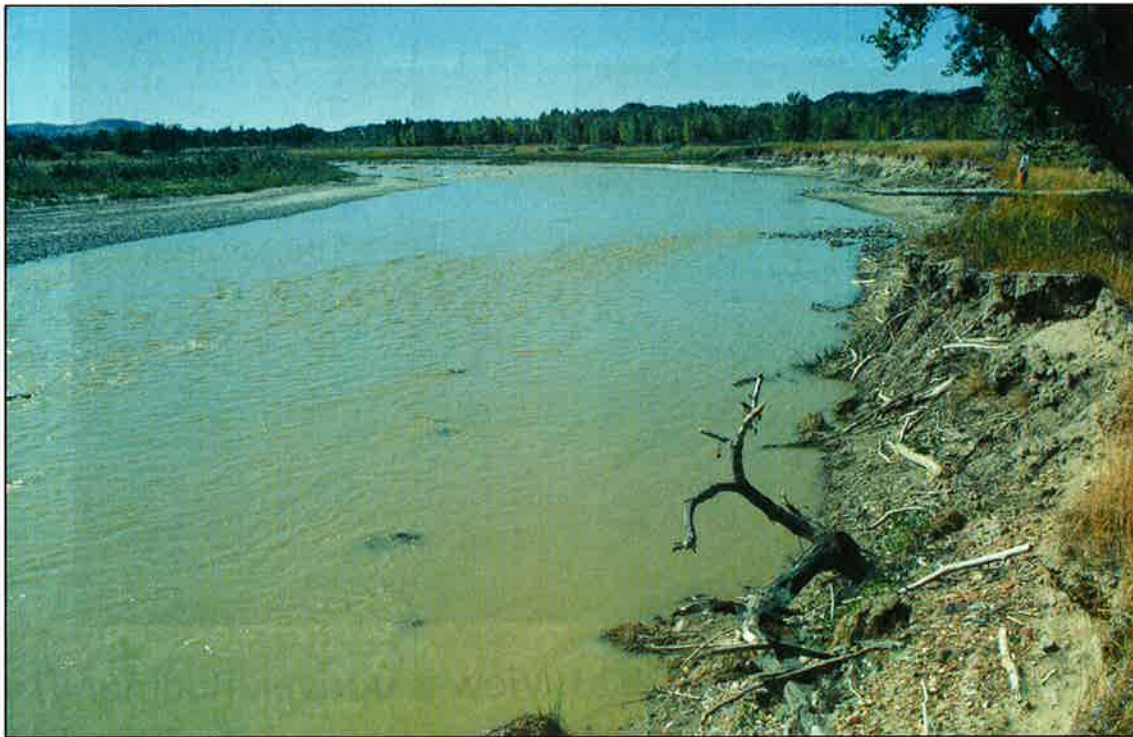
PR122A. **Top.** 25 September 1994. View is upriver and J. Moody and tripod are near the line of section. **Bottom.** 26 September 1995. View is upriver and J. Moody is on the line of section.

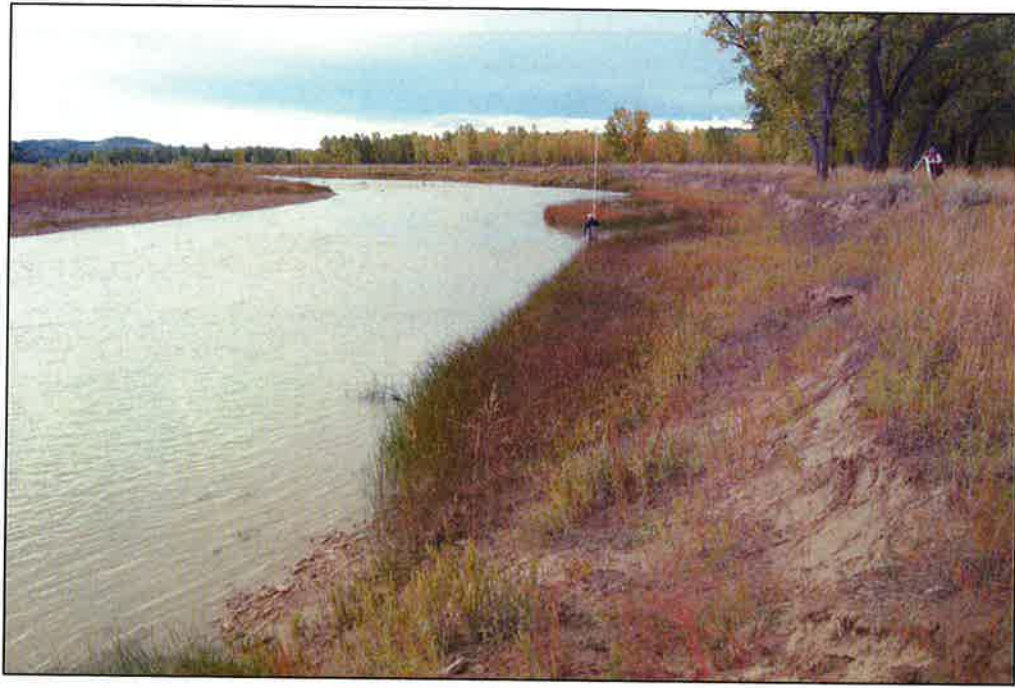
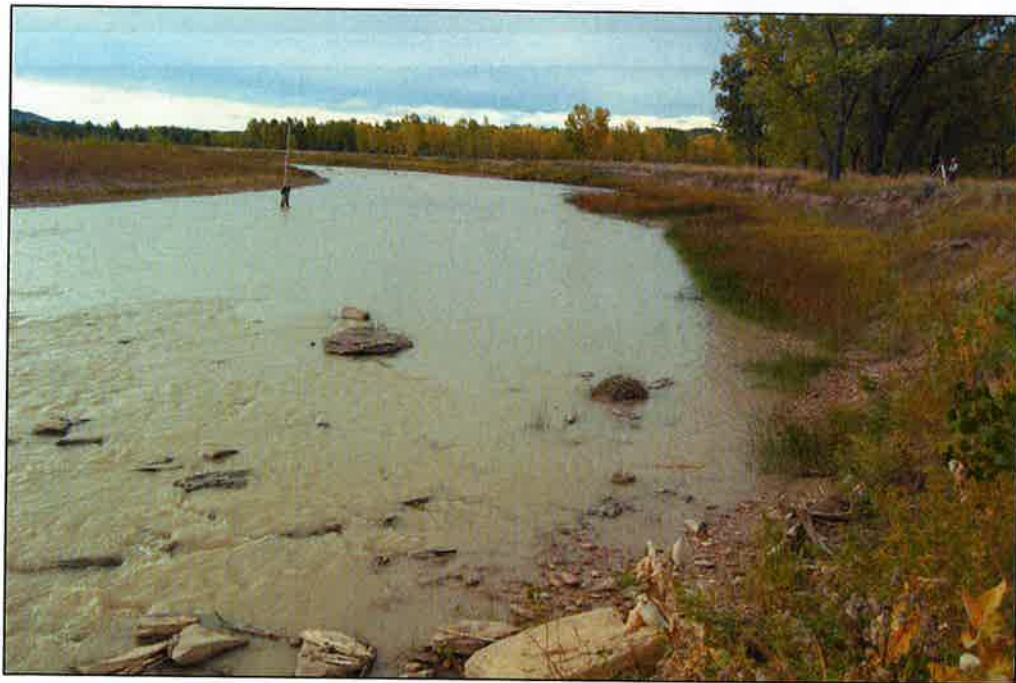
PR122A. **Top.** 29 September 2013. View is upriver. Rodman (J. Moody) is near station -15 at the edge of the sedge. Tripod and D. Martin are ~6m upriver of station -22. **Bottom.** 29 September 2013. View is upriver. Rodman (J. Moody) is on section near station +15, which is where the edge of the left bank stood in 1984 (Edge of left bank stood at station +31 in 1979).
